# Material and Quality Description of Quartzite

This quality description aims to define when irregularities in quartzite natural stone can be considered valid grounds for a complaint and when they are a natural part of the stone's character.

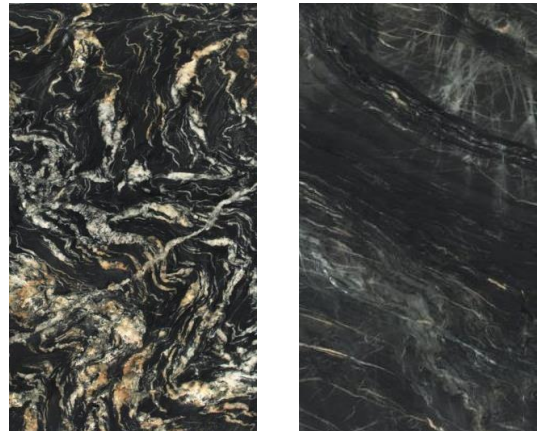
*The images show two different slabs of the same stone type.*

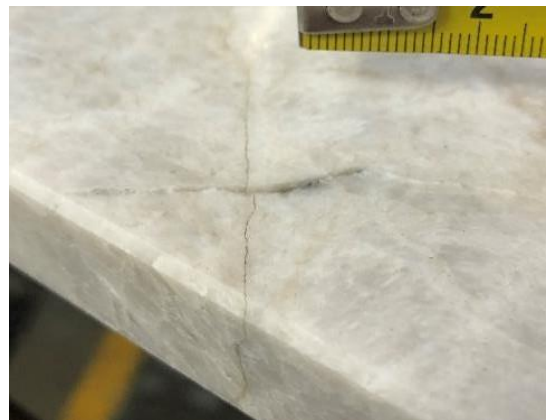
*This image shows a minor glass vein, which may visually be mistaken for a crack.*

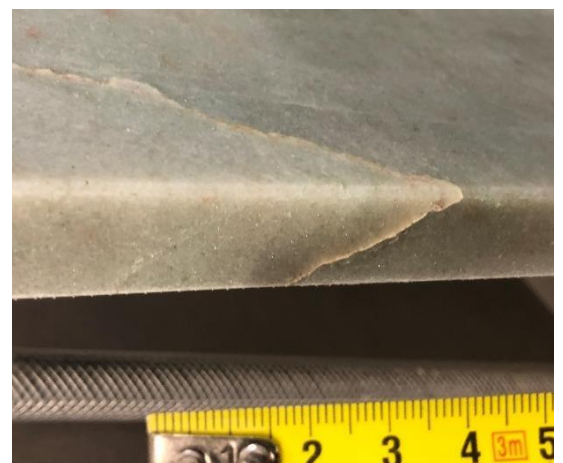
*This image shows a vein, which may visually be mistaken for a crack.*

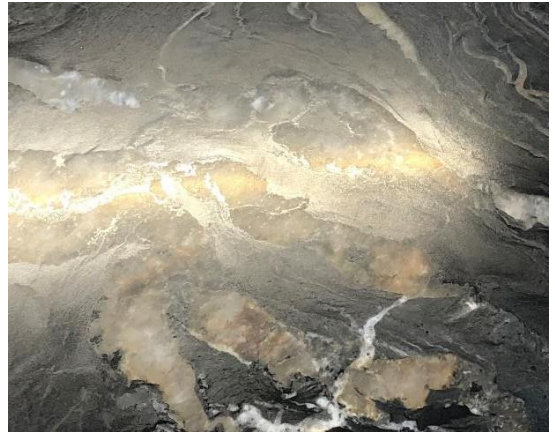
*The image shows differences in reflection resulting from variations in mineral composition. These differences can be both seen and felt.*

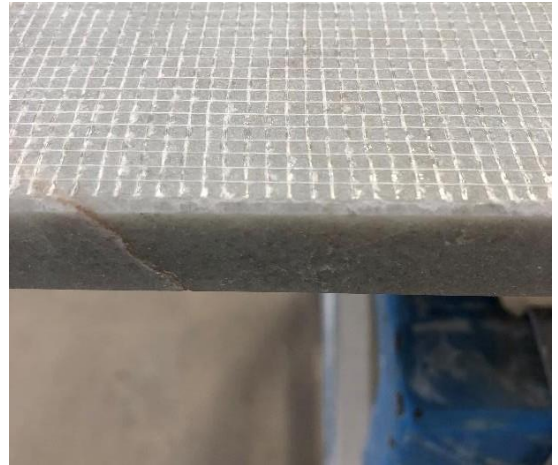
*The image shows the underside of a slab, where the mesh extends all the way to the front edge.*

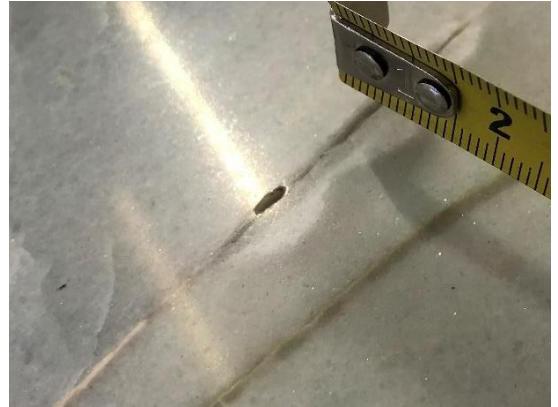
*The image shows a depression running along a natural vein.*

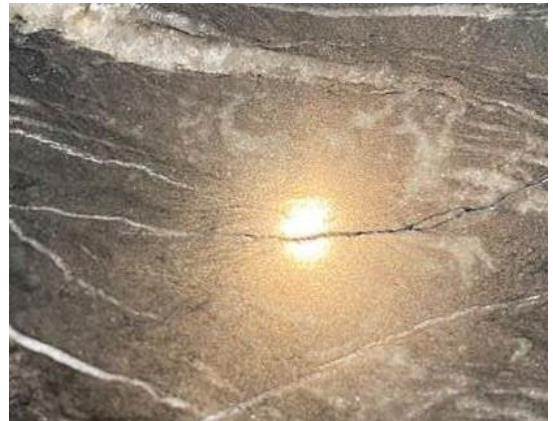
*The image shows a fissure running along a natural vein.*

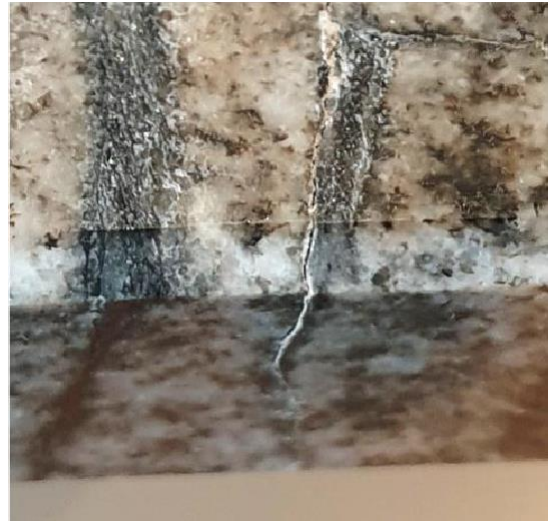
*Close-up of a leading edge and the underside of the worktop, showing a through-crack with a visible gap between the fracture surfaces.*

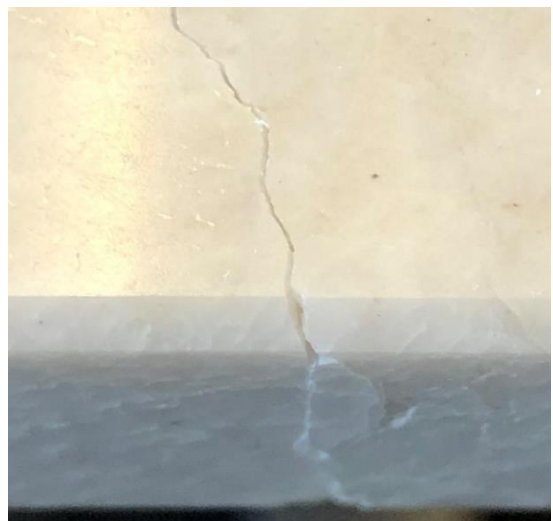
*An example of a through-crack with a clearly visible gap between the fracture surfaces.*
